**Flood Control Project Maintenance  
Levee Inspections**

**Fall 2011 Levee Maintenance Deficiency Summary Report**

**Levee Inspection Report By Mile - Fall 2011**

**City of Sacramento**

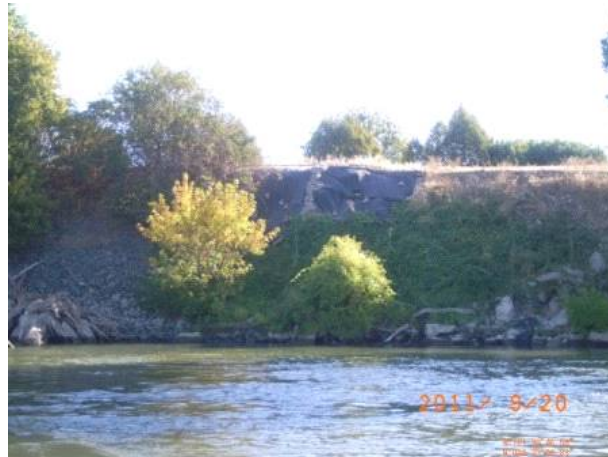
USACE 2011 Photo #1

Levee Mile Report Line	15
Start Levee Mile	2.84
End Levee Mile	2.84
Location	Water Side
Category	Supplemental
Item	USACE Erosion Survey
